FIFTH WHEELS

SERVICE BULLETIN

Inspection and Replacement of Rubber Upshock Cushions

June 1, 1993

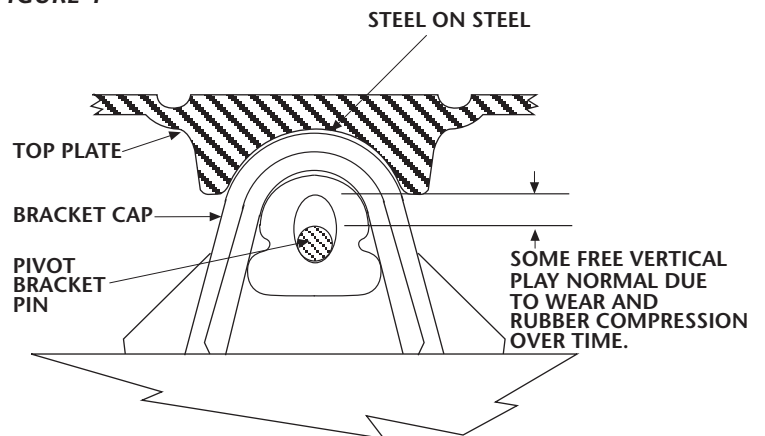
FIGURE 1

Inspection and replacement of rubber upshock cushions should be part of the routine preventive maintenance program. The bracket pivot joint on Holland fifth wheels is designed to be steel on steel for vertical down loading and rubber cushioned on uploading. Due to wear in the top plate and bracket cap interface and compression of the upshock cushion, it is normal to see some free vertical movement at this joint. This vertical movement does not constitute a safety concern because the drawbar loads are transferred through the steel on steel interface, not transferred through the pivot bracket pins. See **FIGURE 1**.

The rubber upshock cushions should be replaced when the free vertical movement (without rubber compression) exceeds $.38''$. If the vertical movement exceeds $.5''$, the vehicle should be taken out of service until repairs can be completed.
